OFFICE OF THE INSPECTOR GENERAL

AIRCRAFT FUEL CELL PROCUREMENTS

Report No. 94-001

October 13, 1993

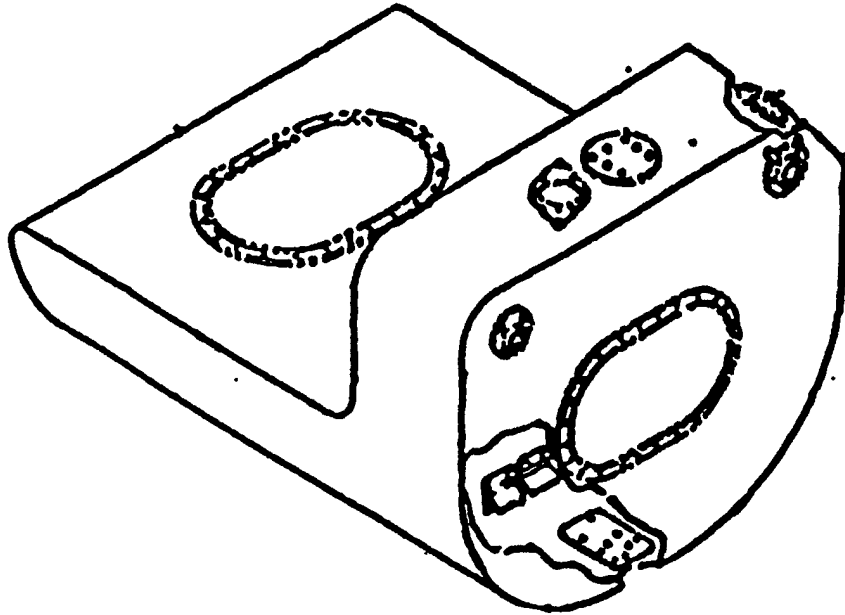
Figure 3. AH-64 Helicopter Forward Fuel Cell

Review of 146 fuel cells located at 4 Army sites showed that 42 were damaged because of improper storage and handling (Appendixes C and E). Of the 146 fuel cells, 21 were damaged beyond repair. The most significant problem occurred at Letterkenny Army Depot with the AH-64 helicopter forward fuel cell. The forward fuel cell collapses more easily because of its "L" shape, as seen in Figure 3. Fifteen of the forward fuel cells at Letterkenny Army Depot collapsed in their shipping containers and could not be straightened out. When the cells remain collapsed over a period of time, the self-sealing material migrates away from the creases in the fuel cell wall, leaving no self-sealing ability in the area and causing separation between plys.
